Safety at Seas: Bulk carrier structure

Bulker safety: Structural strains

A decade ago, the IMO review of bulk carrier safety noted many structural risks facing such vessels. Safety expert Dennis Barber says it is time to review the stresses and strains that bulk carrier hulls still face

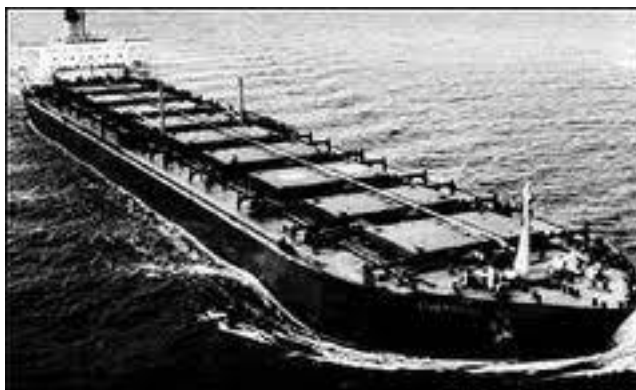
'Derbyshire', lost with all crew in a typhoon

In the list above the causes of failures were not fully understood. Research into hatch cover failure was, until seafarer input was sought and incorporated, preoccupied with vertical forces. The evidence from the 1980 sinking of Derbyshire suggested that the hatches collapsed under weight of water. This may have been the case and it was officially acknowledged as such, but it was far more likely that the failure of hatches and air pipes came initially from the forward side of the hatch, not from above. Large waves overtopping the forward end would have enormous momentum that would have been capable of dislodging the hatch covers and shearing off the air pipes exposed to the rush of water across the relatively unimpeded foredeck.

Examination of hatch covers that were found in the hold of the wreck suggests this was indeed the cause. The hatch cover skirt was torn out horizontally, indicating that a large force struck it from ahead. Once dislodged, the cover would have been able to fall into the aperture of the forward hold that previously it had been protecting. It is probable that it would also have been exposed to the huge mass of water bearing down on it from above, and this, together with its own weight, would have projected it into the hold.

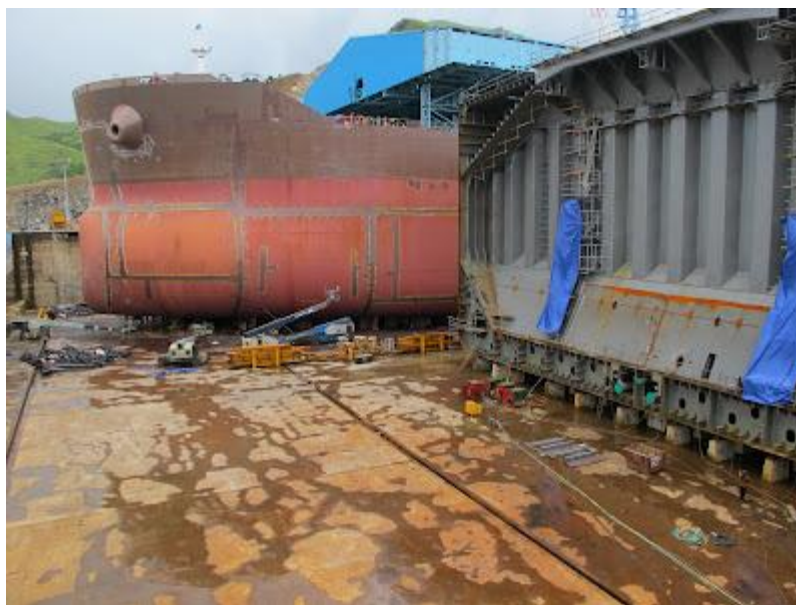
Forecastle adds reserve buoyancy

One issue that generated much agitation among mariners for many years was the loss of the forecastle in large vessel designs. A majority of modern Capesize and many Panamax bulk carriers are 'flush-decked'. The mitigating significance of the forecastle was identified by the FSA, but fell foul of the cost-benefit assessment part of the study.

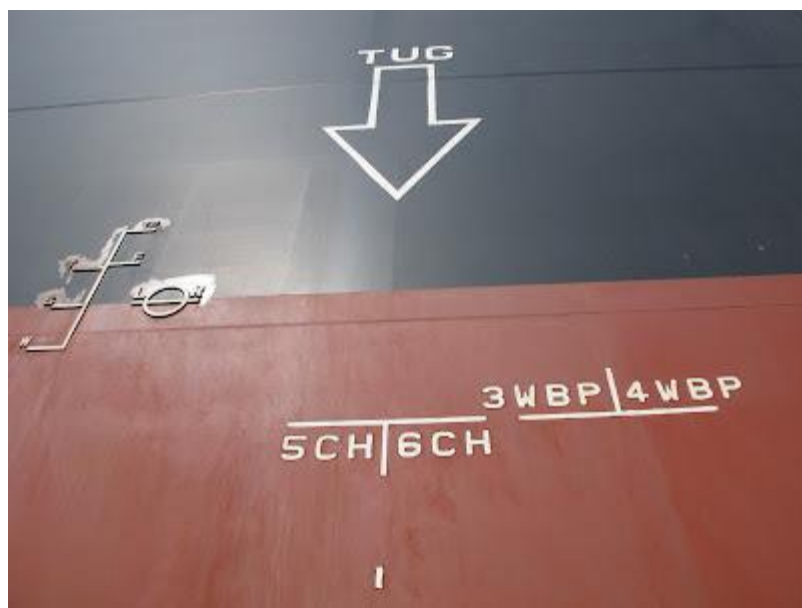
Tug push marks aligned with cargo hold bulkheads

Modern mariners will be familiar with the marks on the sides of large vessels. The tug pushing points are an admission that the side is not strong enough to resist the force imposed by a tug unless it coincides with a bulkhead. The professionalism of tug masters is thus the main mitigation against damage in this area. In the vast majority of cases, they get it right.
